DELAWARE RIVER BASIN
WEST BRANCH MIDDLE BROOK
SOMERSET COUNTY
NEW JERSEY

**WEST BRANCH
RESERVOIR
NJ 00372**

**PHASE 1 INSPECTION REPORT
NATIONAL DAM SAFETY PROGRAM**

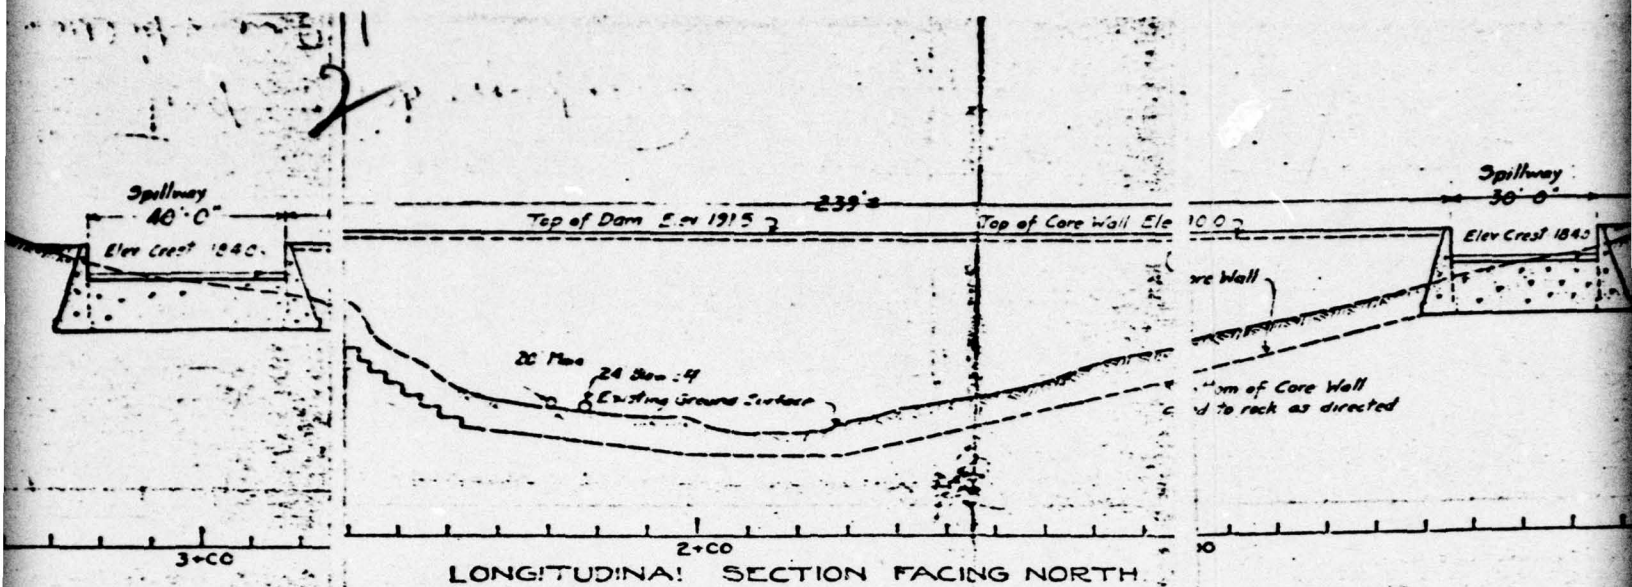
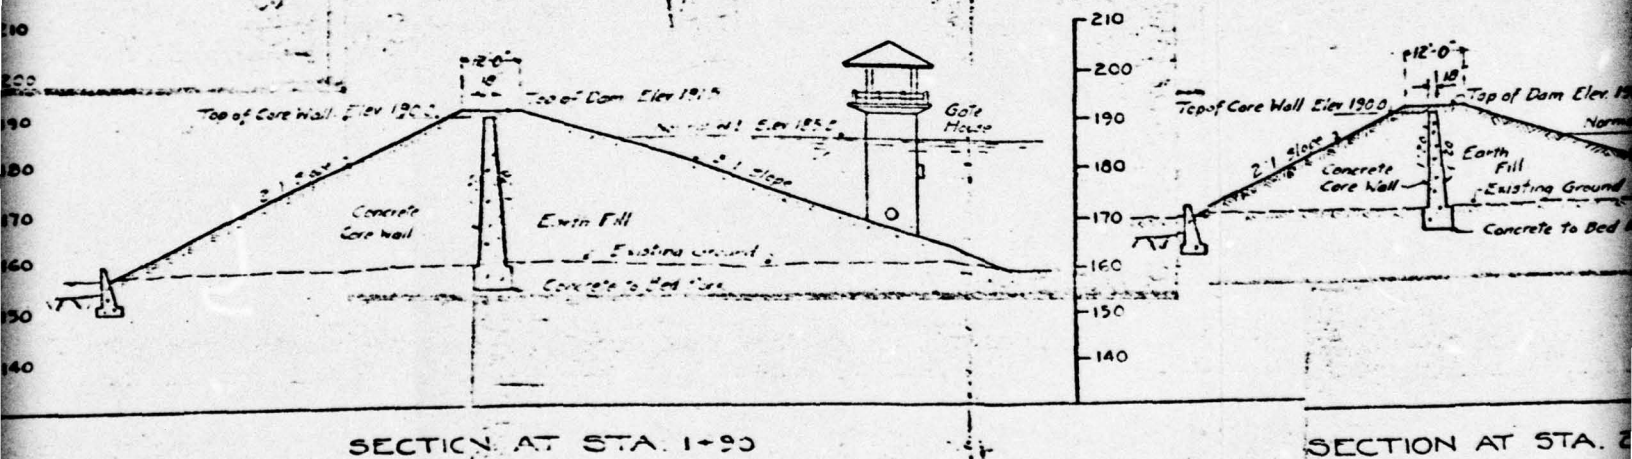
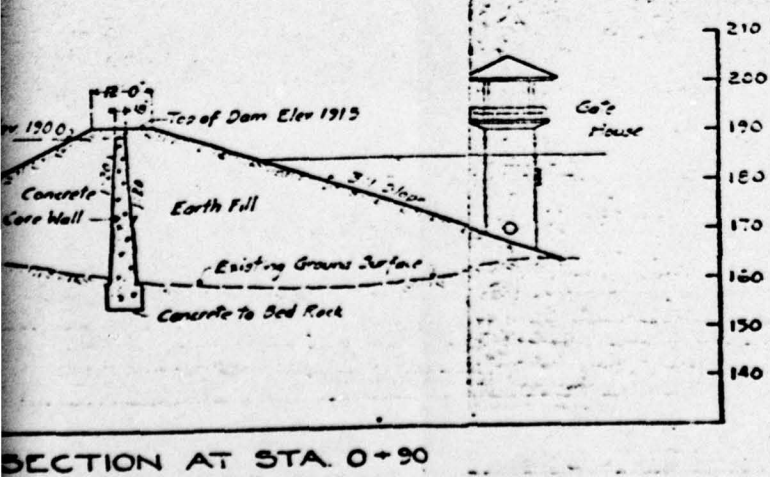
PLATE 4 *B*

Typical sections of the dam are illustrated on Plate 4, and with the exceptions of the two spillways and the crest elevations, they are believed to represent the as-built design. Specifications indicate that the embankment material was to be compacted in horizontal layers of 6 inches or less thickness. Two classes of concrete were specified. The core wall was specified to be Class B concrete, consisting of 1 part Portland cement, 2-1/2 parts sand and 5 parts broken stone and gravel.

The available drawings of the embankment (Plates 3 and 4) represent an earlier design in which two spillways were proposed. Crest elevations on these drawings are incorrect. Drawings of the spillway (Plate 5) are substantially correct with regard to the geometry of the structure.

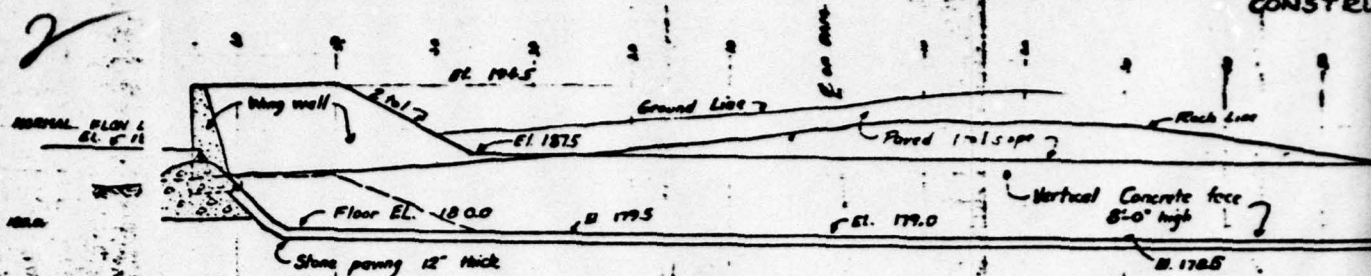
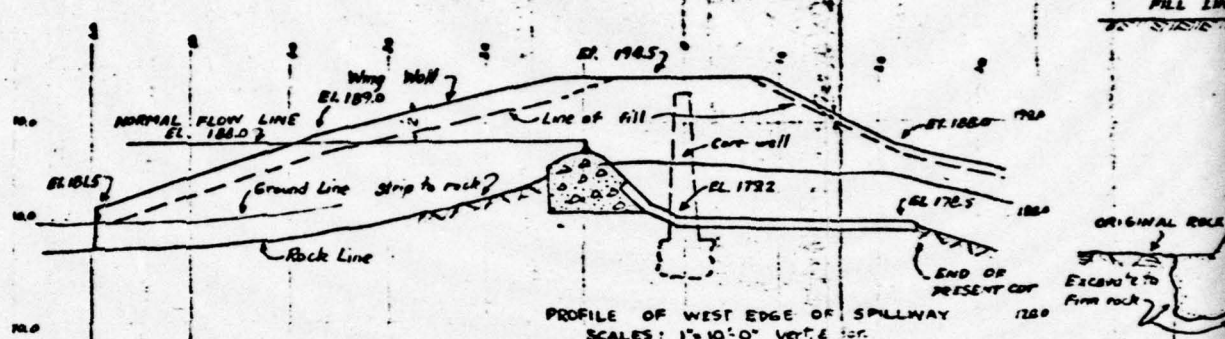
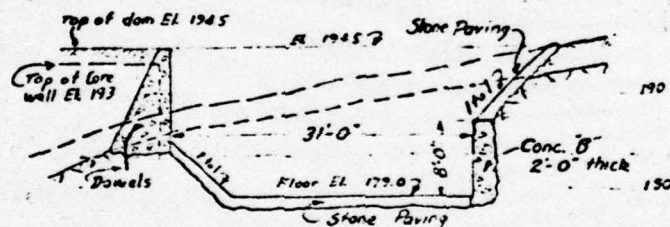
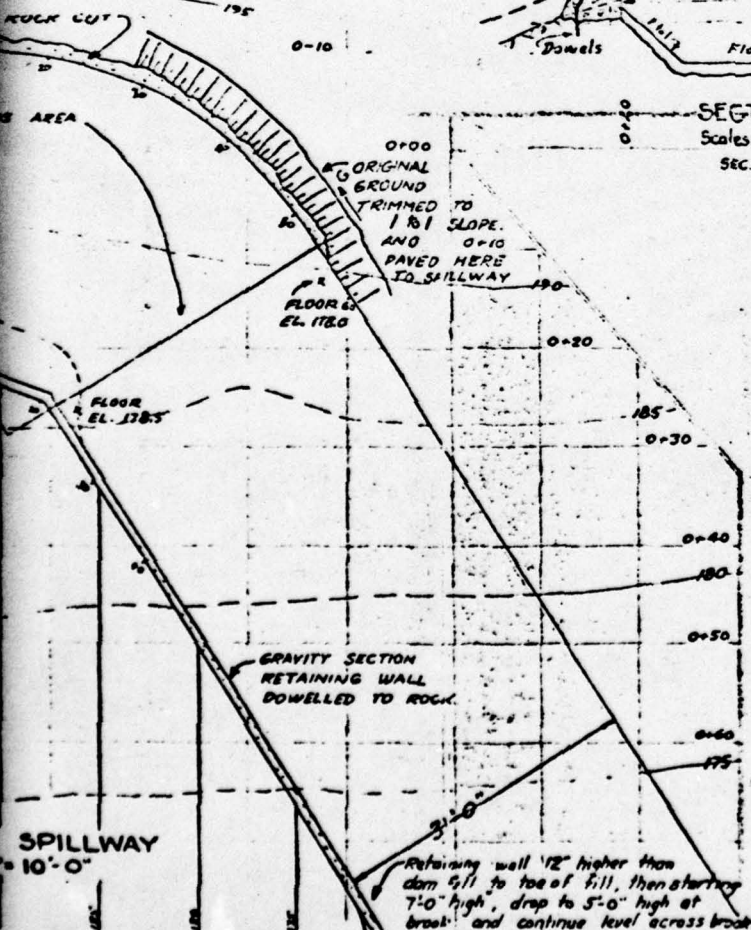
PLATE 5

The spillway is shown in plan on Plate 5. The stone paving indicated on the downstream side of the weir was eliminated during construction because of the good quality bedrock. The spillway was constructed with a groove in the crest designed to accommodate flashboards. The flashboards were attached to the crest by steel ties and were designed to break away under high water level conditions. A request by the engineer to raise the spillway crest a foot higher than shown on the plans was denied by the State.
